Accident report

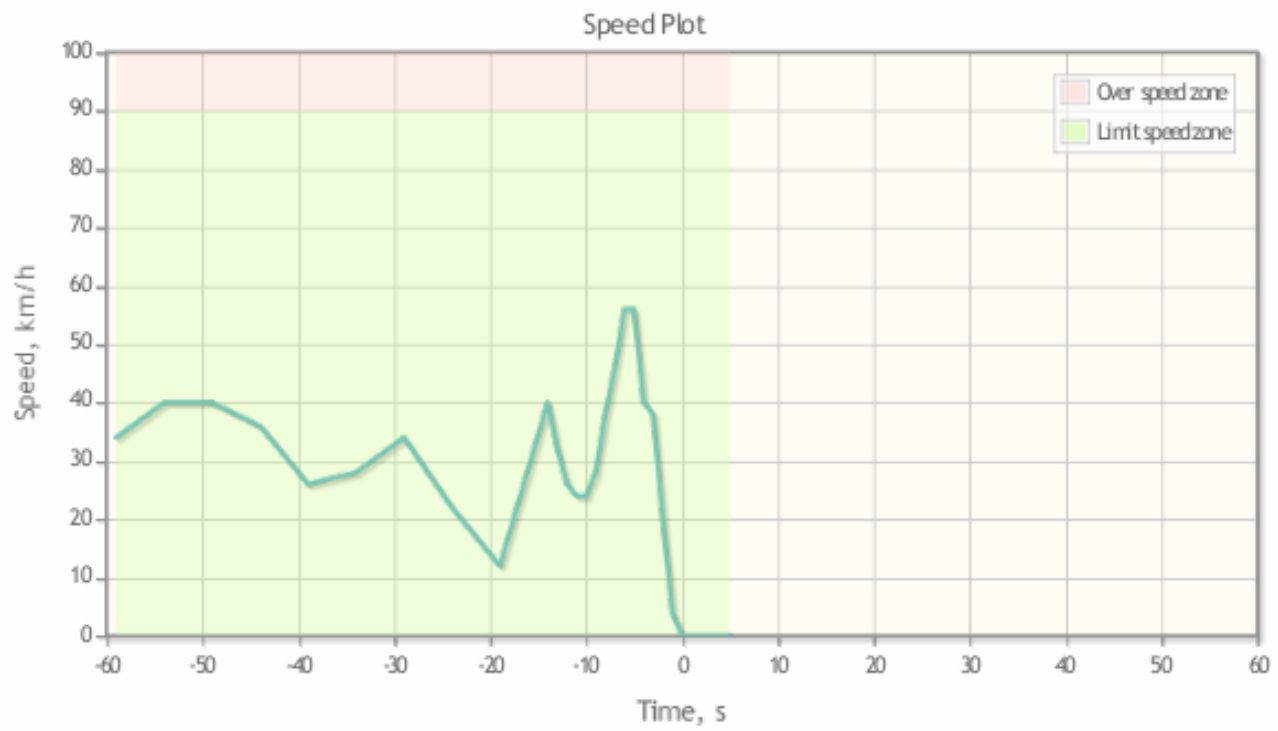
Acceleration Plot

Client Info	
Λογαριασμός	Test Account
Full Name	Test
Vehicle Info	
Συμβόλαιο	111111
Μάρκα οχήματος	Jeep
Μοντέλο οχήματος	Wrangler
Τύπος οχήματος	Car
Αριθμός Πλαισίου	VIN
Body number	
Αριθμός κυκλοφορίας	TEST
Driver	
Driver phone	
Πρόγραμμα	SMART 1Y
Insurance	
Insurance contract	
Insurance contract start date	
Equipment Info	
Activation date	28.02.2022 18:03:39
Αριθμός σειράς κουτιού	Meta T342-S
OBU name	
IMEI	
Accident	
Crash ID	1
Accident created	Detected by device
Conditions	
Temperature	
Weather	
Humidity	
Road class	
Road surface type	
Peak Acceleration	
- X (front):	3,7G (-1,03; 3,7)
- Y (side):	4,22G (-1,27; 4,22)
- Z (vertical):	3,78G (-1,91; 3,78)
